Assessment of housing exposure to accelerated coastal erosion in Keta Municipality of Ghana

Bismark Adu-Gyamfi^{*}, Rajib Shaw, Wanglin Yan

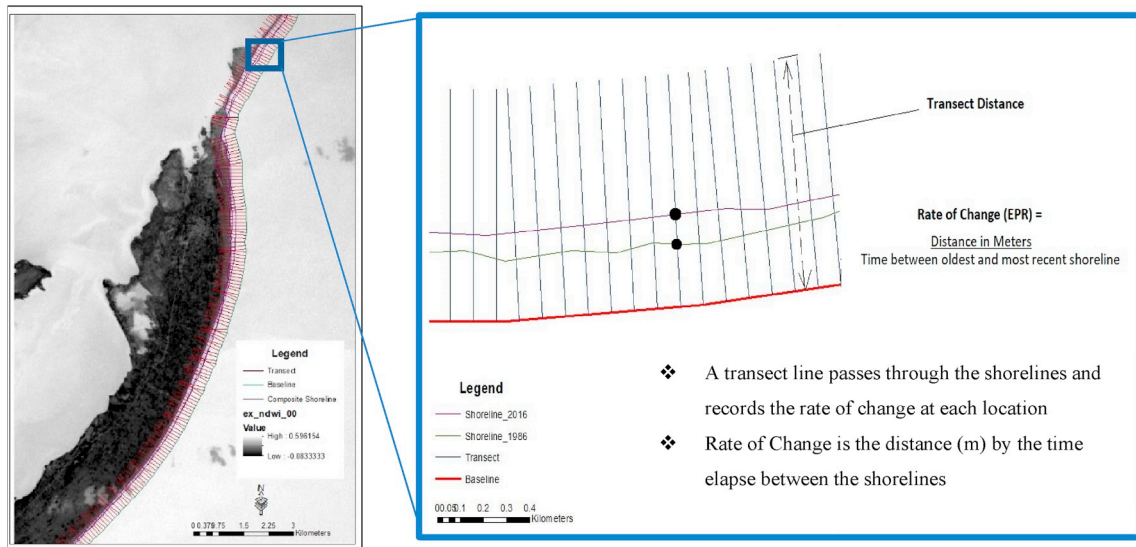
Fig. 3. Shoreline rate of change.

LRR on the other hand determines the rate of change by fitting a least squares regression line to all the shoreline for a particular transect. The rate is the slope of the line. An uncertainty of ±0.4 was assumed and an 80% confidence level was adopted to account for all other uncertainties. This process is shown in Fig. 3.

A geodatabase was created in ArcGIS from which all extracted shorelines were imported. Each shoreline had attributes of ID, Date and uncertainty. To calculate the rate of shoreline, change from 1986 to 2000, the 2000-year image was buffered to a distance of 200 m and the buffer outline was traced to represent onshore baseline with a cast direction of 1. The 2000-year shoreline was appended to the 1986 shoreline which is a pre-requisite requirement for the use of the End Point Rate of Change model (which requires two sets of images). This procedure was repeated for the calculation of shoreline rate of change from 2000 to 2016. The LLR was used to calculate the changes from 1986 to 2016. However, this calculation requires the use of the three sets of images since the model. Therefore, the 2016 shoreline was appended to both 1986 and 2000 shorelines for the calculation of the rates from 1986 to 2016.

DSAS, which is ArcGIS extension was used in calculating the rates. This extension allows the calculation of shoreline rates of change from a time series of multiple shoreline positions. Using the DSAS, a total of 470 transects were cast (north to south) from the onshore direction at an interval of 100 m. The rates were then calculated using the End Point Rate (EPR) for short period and the Linear Regression Rate (LRR) for long period. The EPR calculates the rates by dividing distance of the shoreline movement by the time elapsed between the two datasets. That

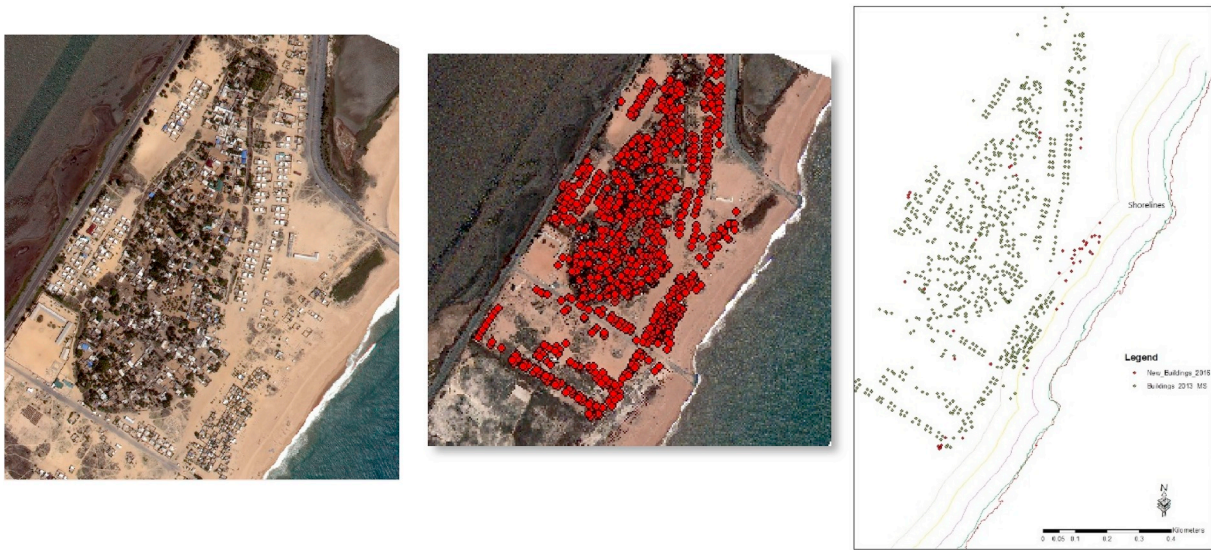
Fig. 4. Identification of housing distribution.

On the other hand, Google Earth software was also used to examine the relative physical expansion of the communities in the study area from 2003, 2010 and 2016 (see Fig. 4).

Geo-rectified Panchromatic and multi-spectral satellite images of QuickBird (acquired on 8-17-2013) and WorldView-3 (acquired on 3-16-2016) were used for building identification and change detection. To determine how the buildings have changed by spatial distribution between 2013 and 2016, the QuickBird (2013) image was assumed as reference year for the change assessment.

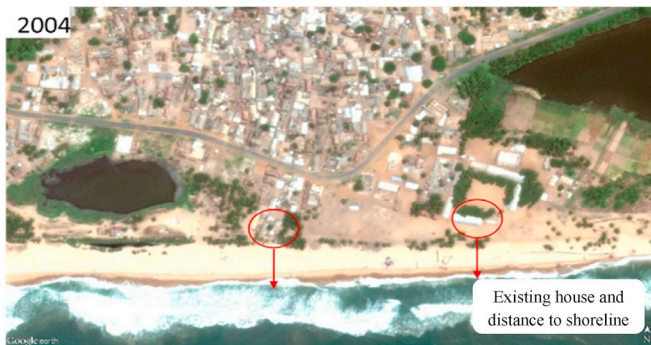
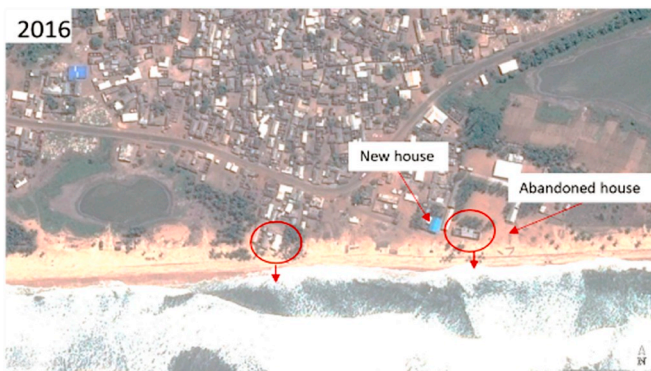
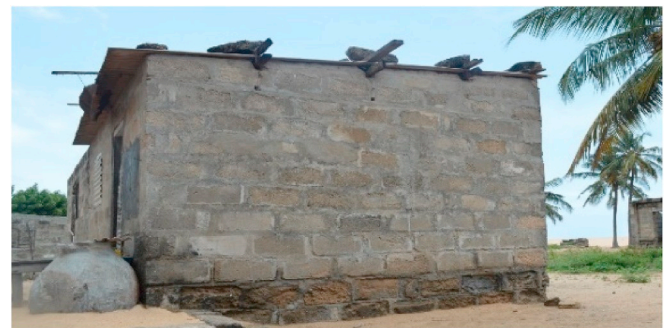
An annual erosion rate of 1.5 m may seem highly positive but this period eroded about 60.17ha of land. Aerial photo comparison between 2004 and 2016 also shows how closer the sea is getting to the communities with some houses in 2004 being abandoned in 2016 (see Figs. 8–10).

Fig. 8. Location of building to sea (2004).
Source: Google Earth

Fig. 10. Effect of erosion on buildings.

Fig. 9. Location of building distance to sea (2016).

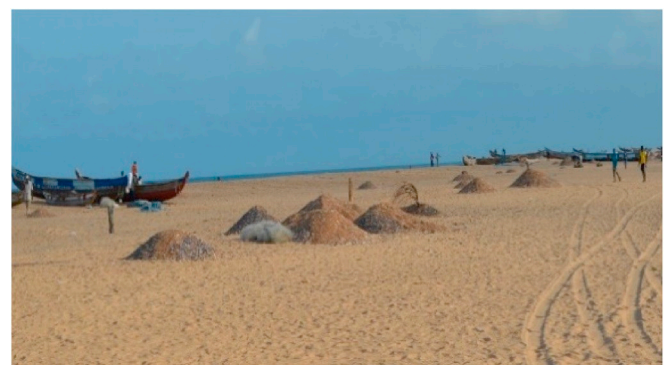
Fig. 11. Pebbles mined from shoreline for housing construction.

It is also established that, the main material for building is cement and sand (72%) while other materials constitute 28%. The demand for sand for construction is prompting the extraction of sand and pebbles from the shoreline (see Fig. 11). These practices further expose the
